Rapid Maximum-On-Ground (MOG) Enhancement Technologies

Report 1

Matting Systems for Contingency Helipads and C-130 Test Sections

January 2005

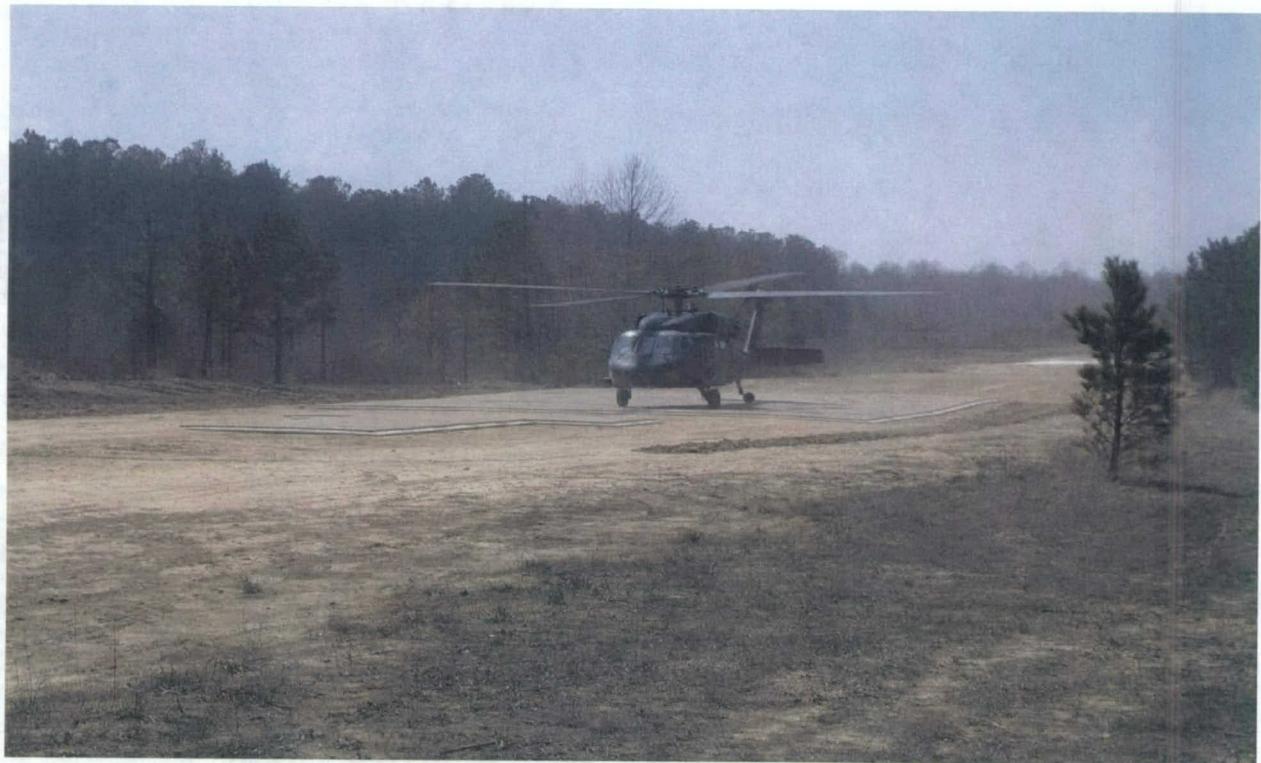
Photo 22. UH-60 Blackhawk operating on DURA-BASE helipad

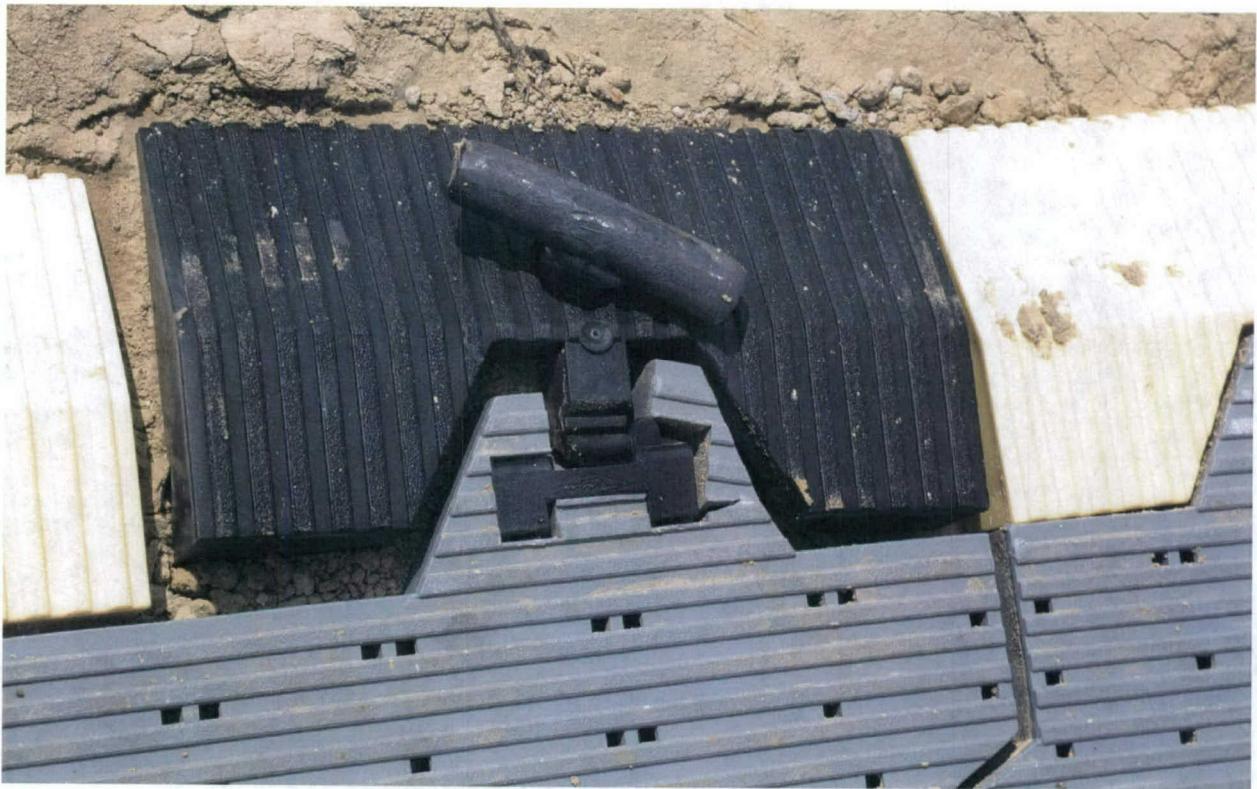
The SUPA-TRAC system performed reasonably well during the helicopter tests. Excess dust and FOD were reduced while the aircraft were hovering directly above or operating on the matting system itself (Photo 23). Inspection of the mats after the limited helicopter operations showed that the plastic panels did sustain some damage (Photo 24). It was not determined if the limited damage occurred as the result of static or dynamic loads. Also, one edge panel loosened during testing because of rotor wash, but no significant deflection or upheaval resulted from this failure. The SUPA-TRAC system is expected to provide improved load-bearing support, but system component durability is questioned because of the damage noted after the very limited traffic and installation.

Photo 24. Isolated structural damage to SUPA-TRAC matting system at helipad edge

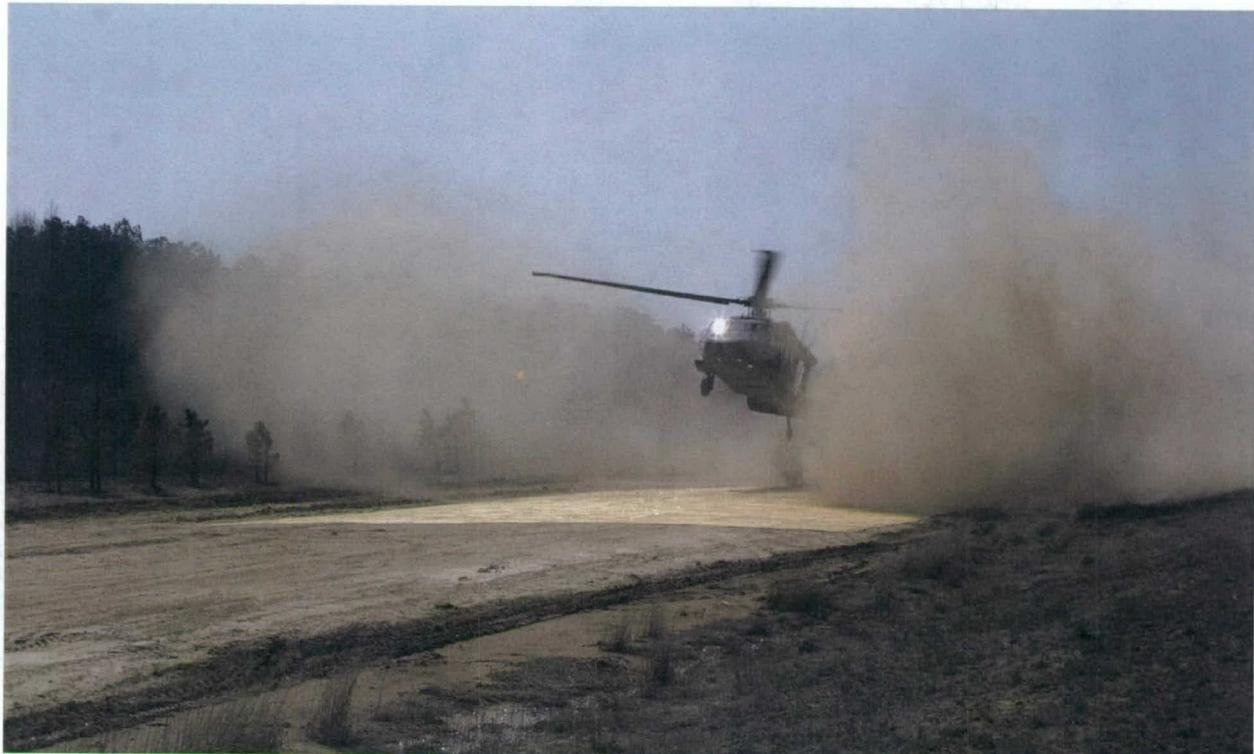
Photo 25. MP Mat helipad diffusing dust cloud as UH-60 Blackhawk approaches helipad

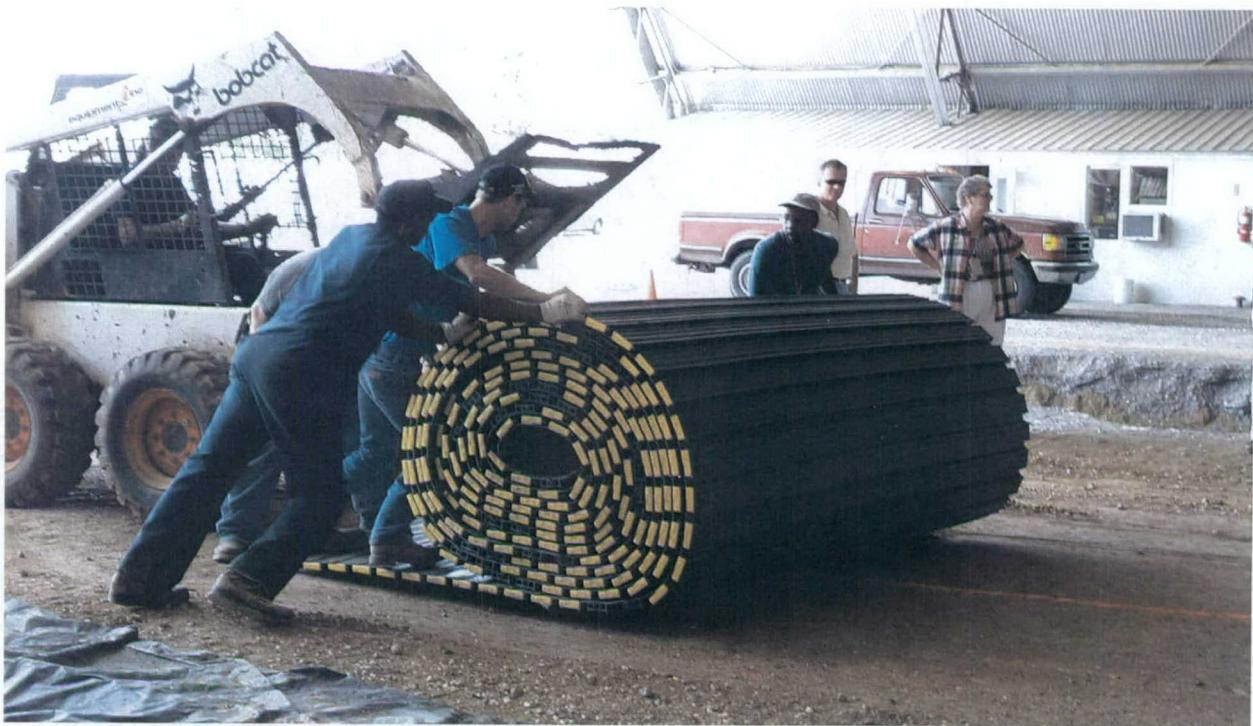
Photo 29. Installing Rolla-Road matting system

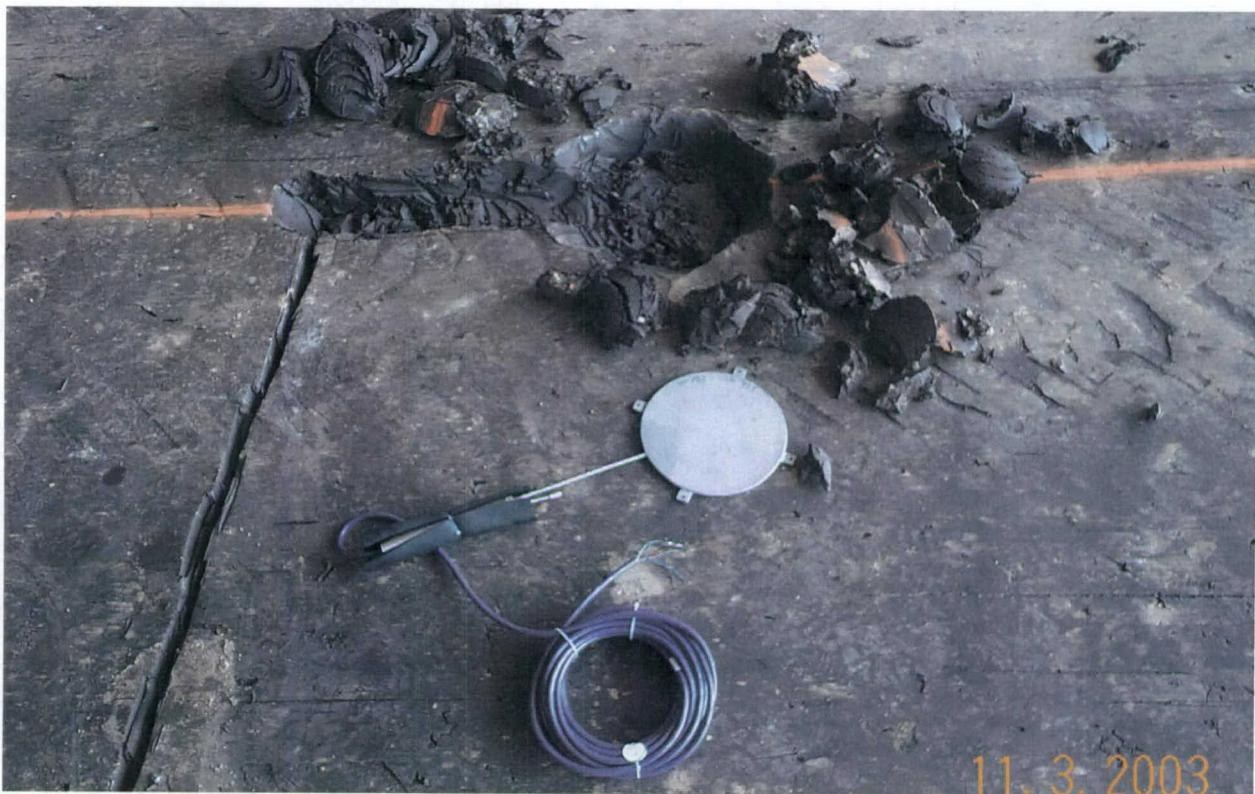
Photo 33. 100-psi GeoKon Pressure Cell awaits placement in CH clay

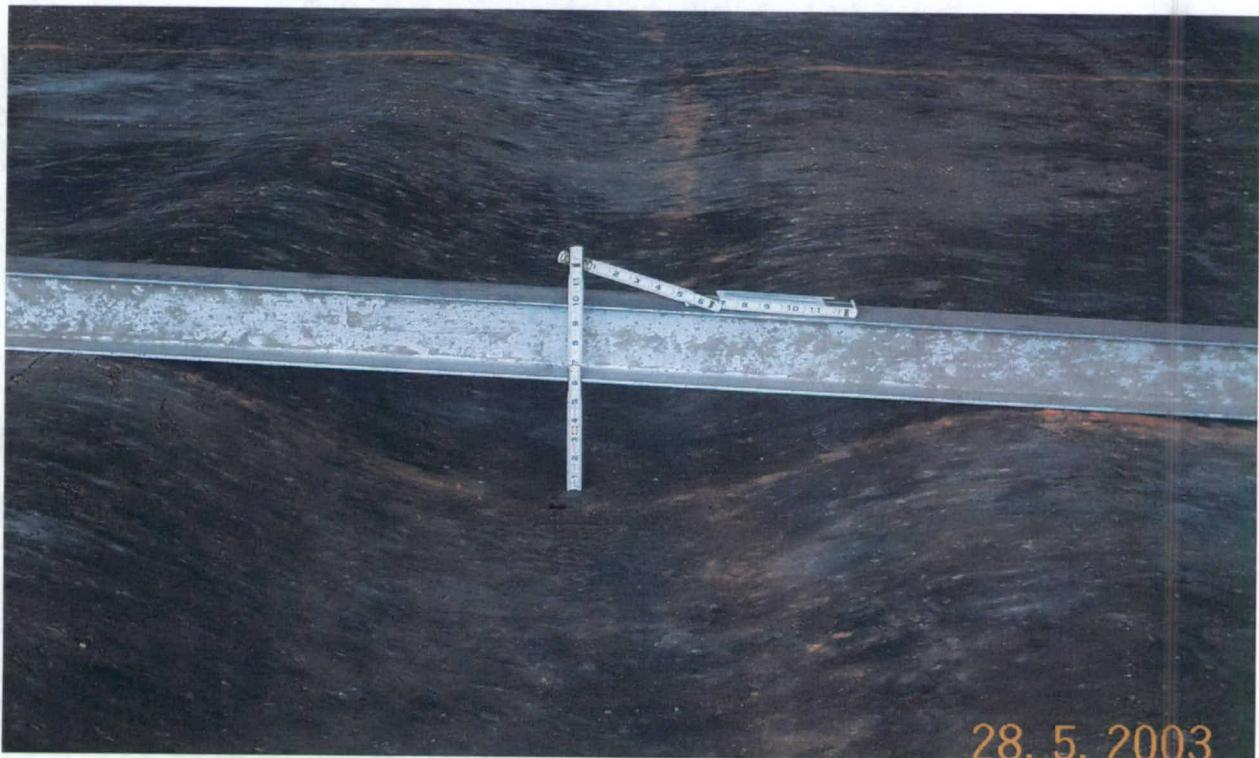
Rapid Mat (FFM) tested poorly during this evaluation, reaching the failure criteria of 76.2 mm (3 in.) in 1,010 passes during the high-strength subgrade testing. Because it performed so poorly, it was not evaluated on medium- or low-strength subgrades. The mats offered little or no structural support and did not improve the soil strength condition for heavy aircraft traffic. During trafficking, deep rutting under the mats caused the outer sections of the mats to exhibit large deflections or bow-wave action. These mats are not recommended for use in MOG enhancement activities but should be used only for FOD prevention.

Photo 34. Measuring final rut depth on the Rapid Mat test (mat has been removed)

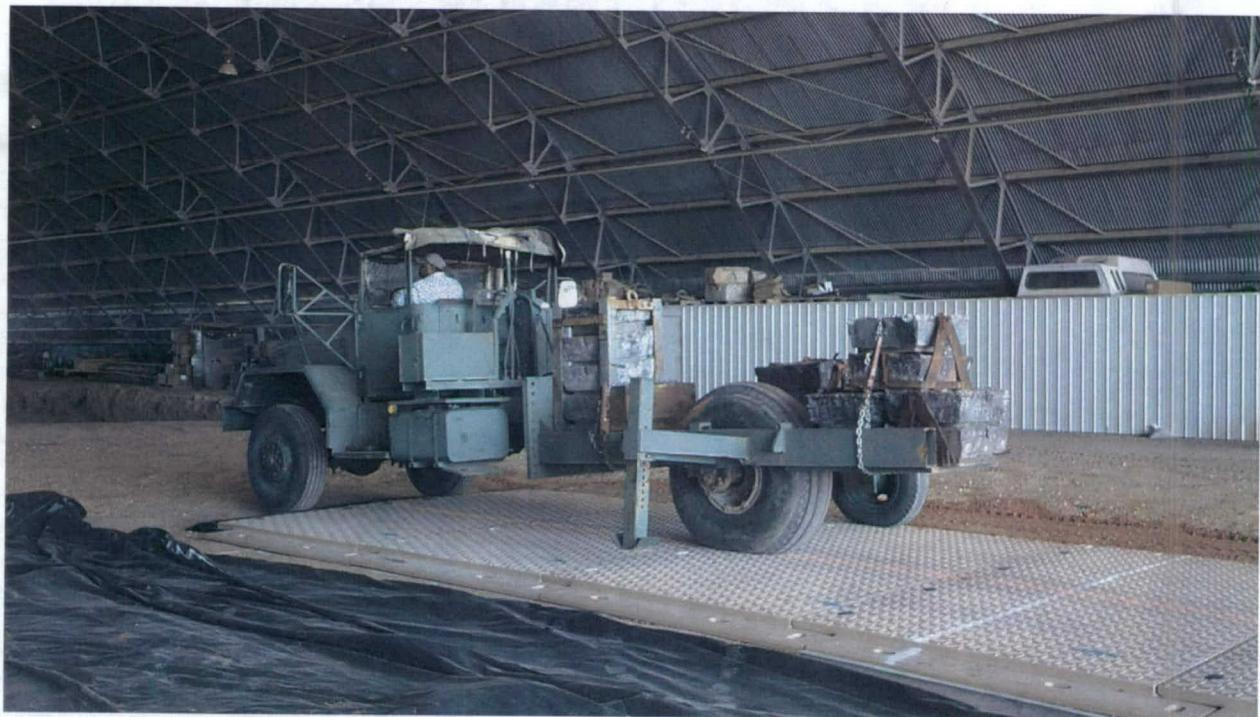
This initial test section evaluation examined the effects of a fully loaded C-130 aircraft on the chosen matting systems. To simulate this loading, the test section used a load cart (modified 2.5-ton truck) fitted with a C-130 tire, loaded with 13,600 kg (30,000 lb) of lead weight. The C-130 tire was inflated to 655 kPa (95 psi), and this combination of load and pressure produced a tire contact area of approximately $3,107 \text{ cm}^2$ (482 in.²). The load cart was driven in a channelized traffic pattern to simulate traffic passes over the matting systems. The traffic was confined to a single wheel-width path to allow accelerated trafficking to be performed. Photo 35 shows one of two load carts used on the test section.

Photo 35. Loaded C-130 load cart performing traffic test on DURA-BASE matting

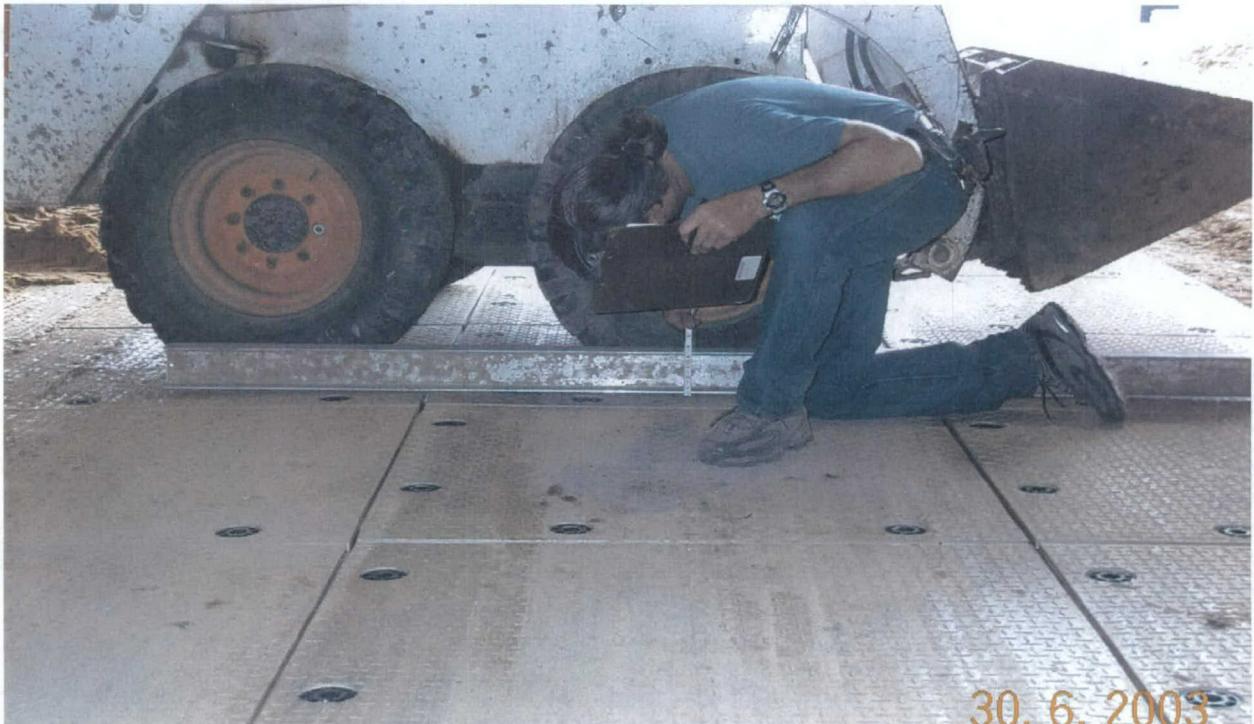
ficking required the use of a small skid-steer multipurpose machine to provide a positive compression force, using its front wheels, to deform the mat into the rut present at the measurement interval. The strength and stiffness of the DURA-BASE required the use of the larger front-end loader to provide this same positive compression force. This practice is shown in use on the SP-12 matting system in Photo 36.

Photo 36. Using the skid-steer multipurpose machine to measure mat in-place rutting

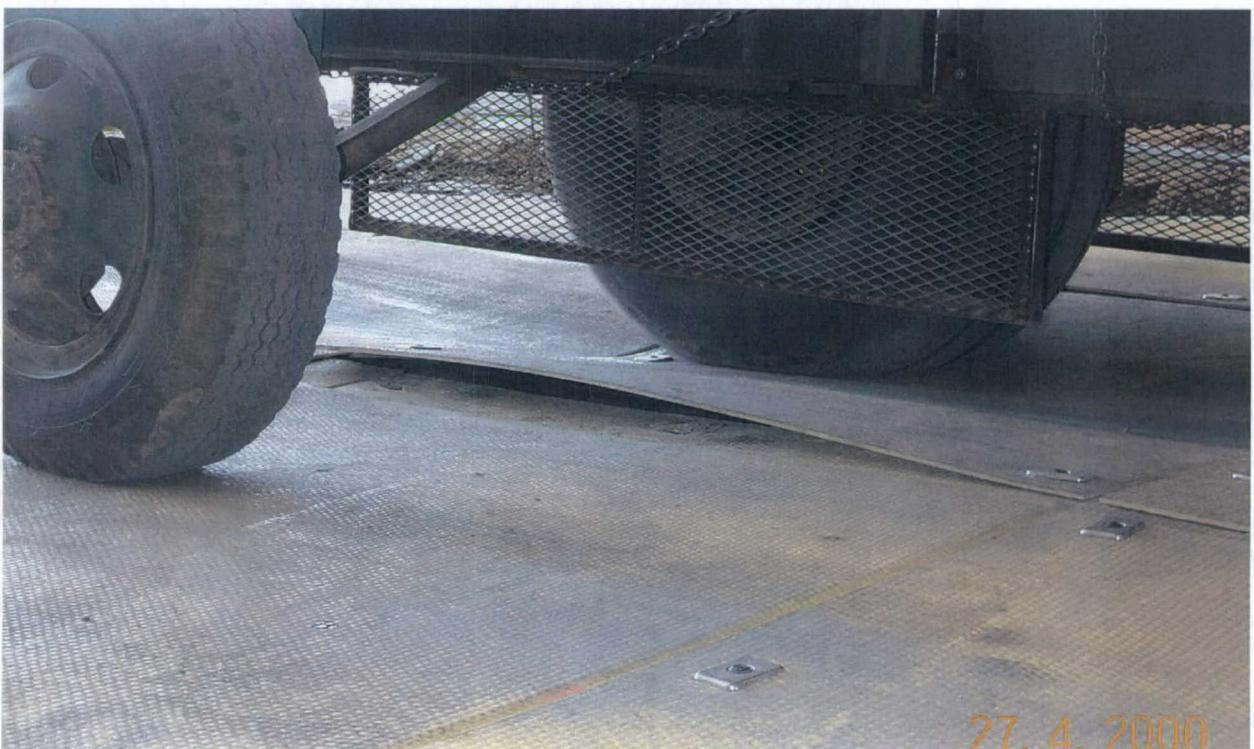
The MP Mat, although not as resilient as the DURA-BASE, performed well during the test section evaluations. This matting system was able to withstand the minimum 2,000 passes with less than 76.2 mm (3 in.) of mat deflection for the 40 to 50 CBR soil subgrade (high-strength subgrade). The mats did show some large secondary deflections (away from the traffic path) once the point of deflection failure was approaching. This reaction to the progressive rutting of the weak soil beneath the mat caused minor pin problems during the second and third stages of testing (8 to 10 CBR and 3 to 5 CBR, respectively) in which pin pop-outs occurred (see Photo 37). These popouts totaled less than 10 percent of the total pins installed, and the failure of this small number of pins did not constitute failure of the mat in the test section. In addition, there were several pins within the system that showed signs of minor movement within the connection, but none of these pins failed prior to test completion (see Photo 38). MP Mat allowed 330 passes before reaching the failure criteria during the medium-strength (8 to 10 CBR) subgrade testing and sustained 55 passes before failure during the low-strength (3 to 5 CBR) subgrade testing.

Photo 37. Secondary deflection of MP Mat on low-strength soil (3 to 5 CBR)

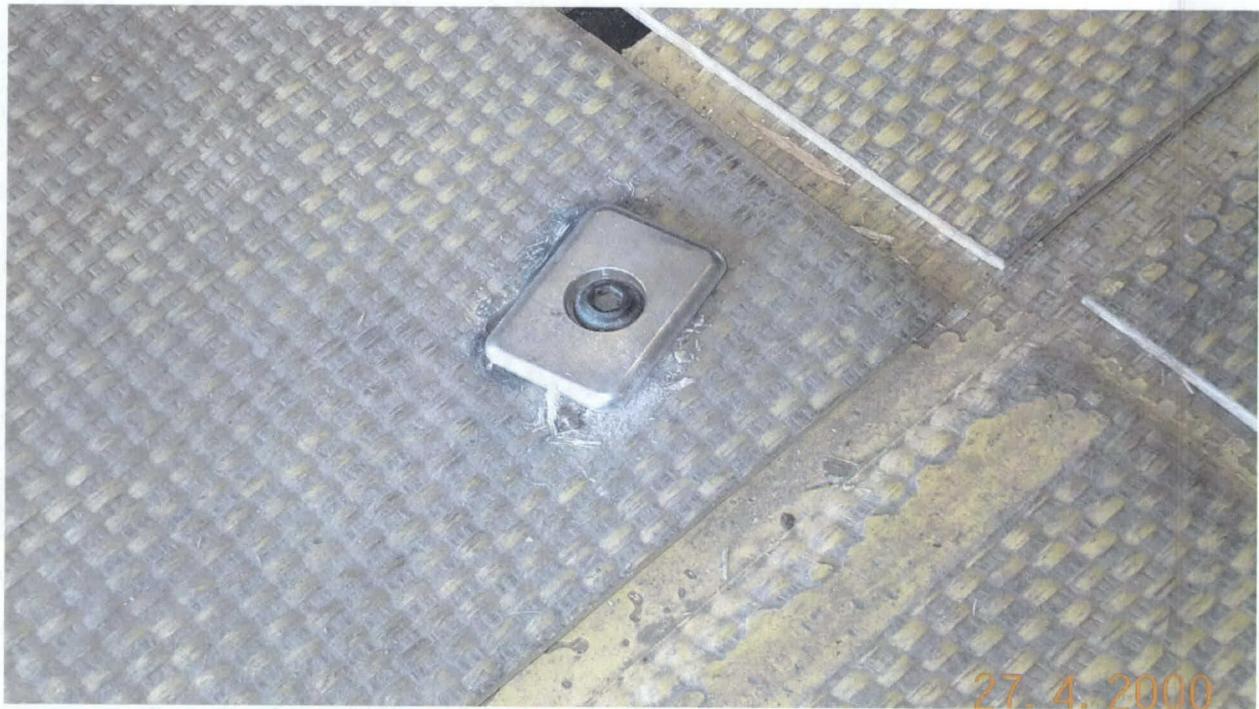
Photo 38. Movement of MP Mat pin within connection. Pin did not fail. (Low-strength soil, 3 to 5 CBR)
